Mobile Intel® Celeron® Processor on .13 Micron Process in Micro- FCPGA Package

Specification Update

September 2004

Document Number: [251309-022](#)

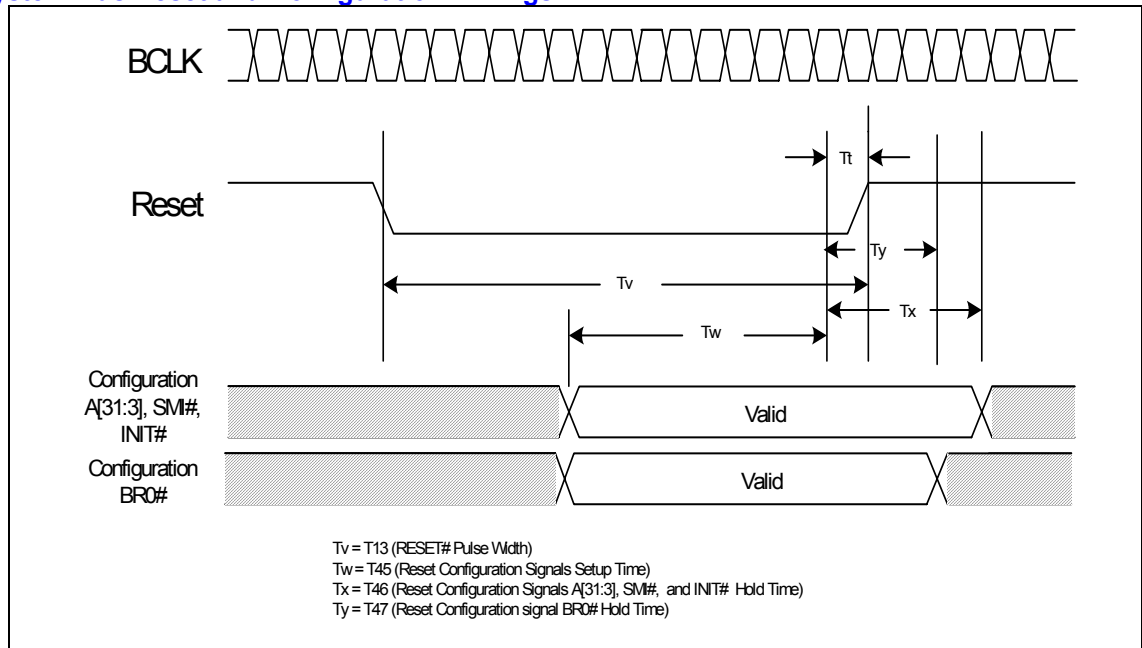
Figure 12. System Bus Reset and Configuration Timings

The BR0# maximum hold time has changed to 2 BCLKs. This change will be shown in the “System Bus AC Specifications (Reset Conditions)” table and “System Bus Reset and Configuration Timings” figure of the *Mobile Intel® Celeron® Processor on .13 Micron Process in Micro-FCPGA Package Datasheet*. This change will be incorporated in the next revision of the datasheet.

The following figure is modified to reflect this change:
